Effects of Different Fuel Specifications and Operation Conditions on the Performance of Coated and Uncoated Superheater Tubes in Two Different Biomass-Fired Boilers

Published in:
Applied Energy Materials

Publication date:
2018

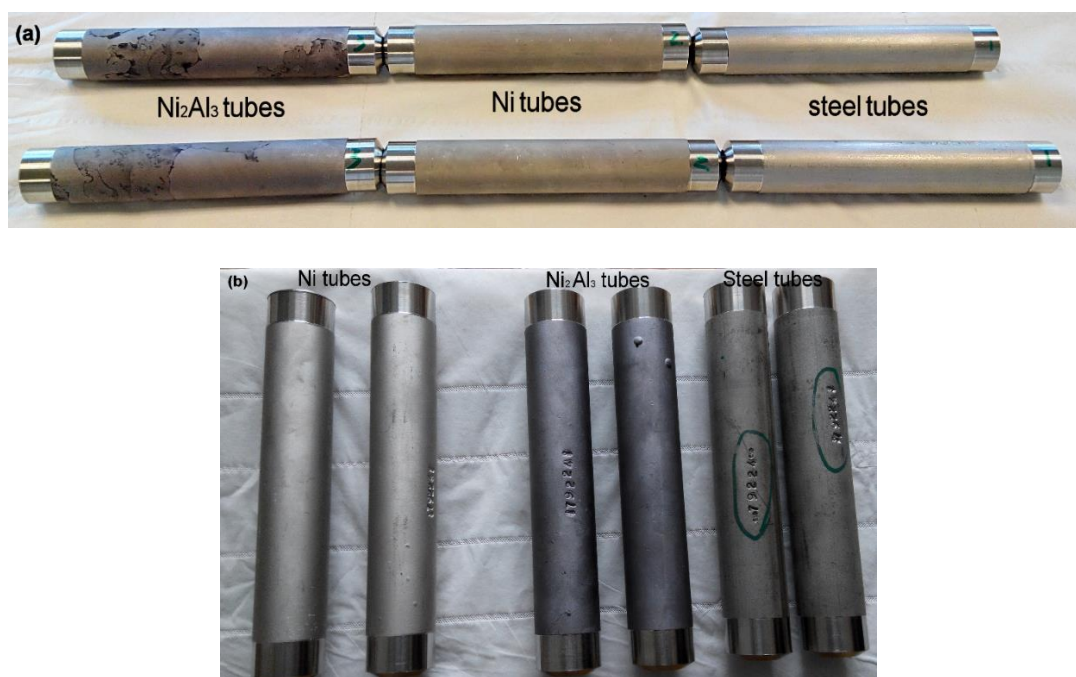
For aluminizing, the Ni coated tube sections were embedded in pre-mixed pack powders (10 wt. % Al + 8 wt.% AlCl₃ + 82 wt.% Al₂O₃), which were put into a cylindrical metal crucible. The crucible was then placed in the tube furnace with flowing argon. The furnace was heated to 650 °C with a heating rate of 18 °C/min, and maintained at this temperature for 6 h. The samples were afterwards cooled inside the furnace by switching off the power while maintaining the argon flow. After aluminizing, the Ni₂Al₃ coated tubes were ultrasonically degreased in acetone and subsequently dried with ethanol. The coating was removed by machining from a 2 cm wide area from both ends of the Ni₂Al₃ coated tubes prior to welding. The tubes after preparation are shown in Figure 1. The discoloration area on the Ni₂Al₃ tubes (Figure 1a) is due to a thin (around 2 μm) Al₂O₃ layer, which was probably related to surface oxidation during furnace cooling or the last part of the pack aluminizing process. Destructive examination from similar locations revealed that the Ni₂Al₃ coating beneath the thin layer was intact and uniform. The bubbles visible on Ni and Ni₂Al₃ tubes (Figure 1b) were probably due to hydrogen gas introduced during the Ni-plating process.

Figure 1. Appearance of the test tubes for (a) Esshete 1250 and (b) TP347H.

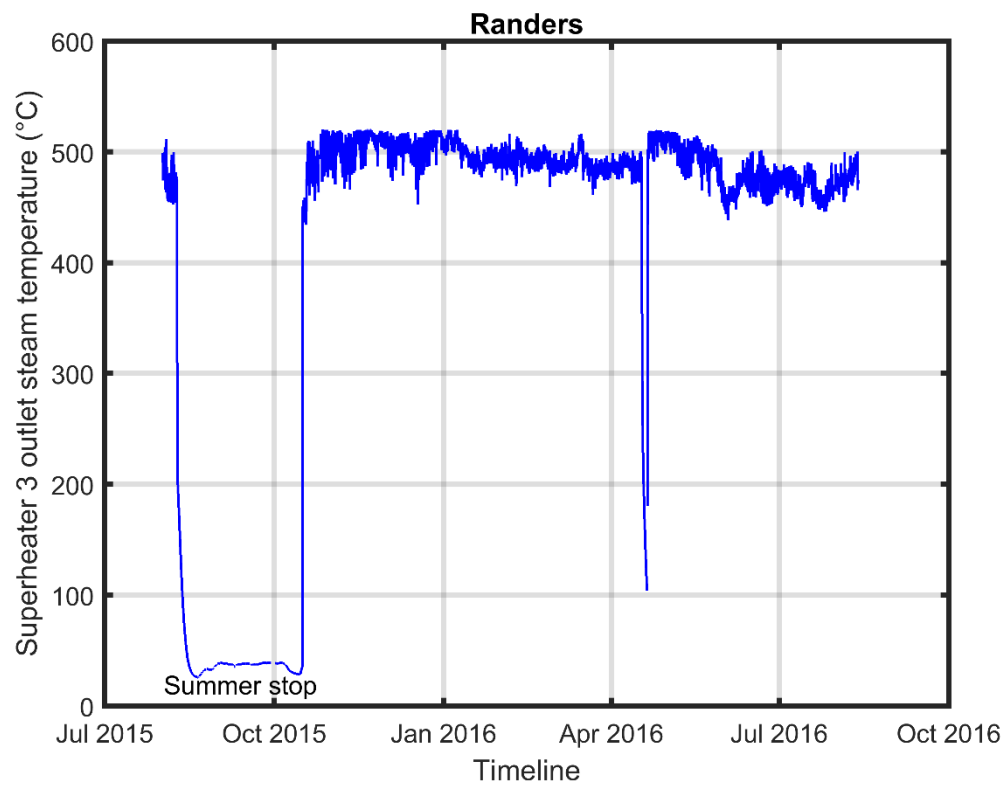
The operating conditions for the two CHP plants are also different. At Randers it is preferred to run at part load rather than shutting the plant down when the heat demand is low, and as shown in Figure 2, has only had one shutdown during the exposure period. However, at MSK the plant is run under cyclic conditions with daily start/stops in the beginning and end of the heating season (Figures 3 and 4). This means that at MSK the boiler runs at full load when in operation. This difference in operating conditions can also be seen when comparing the temperature histograms, which is broad for the Randers plant, and narrow for the MSK plant (Figure 5).

Figure 2. The outlet steam temperature data for the exposure period in Randers.

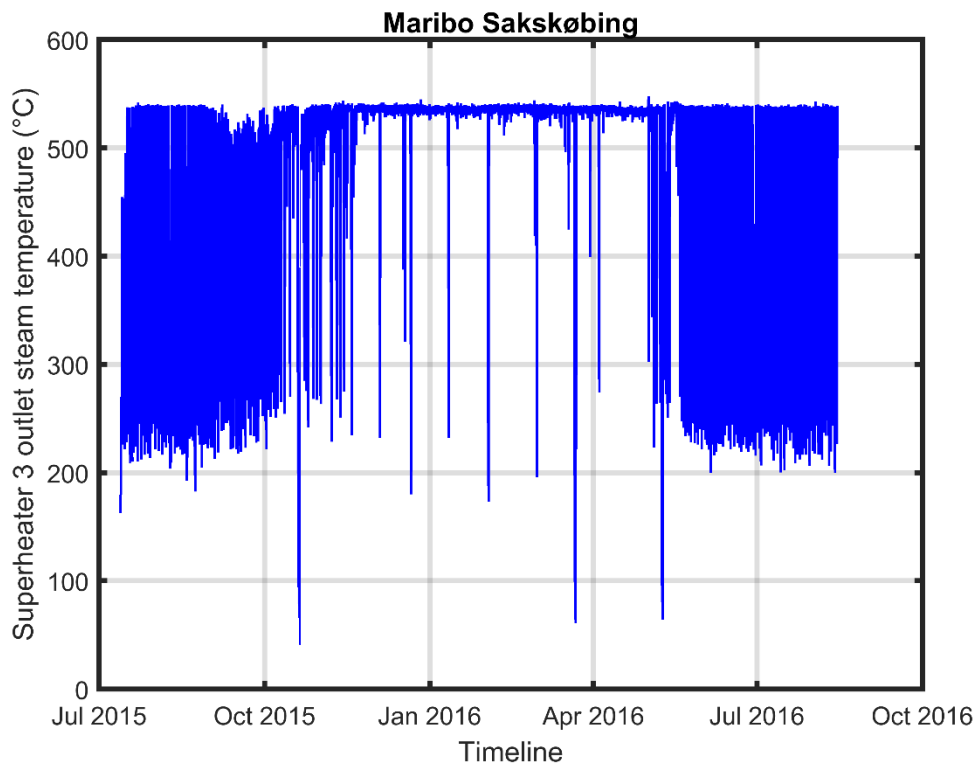
Figure 3. The outlet steam temperature data for the exposure period in MSK.

Since there are many thermal cycles at MSK (Figures 3 and 4), the most probable explanation for the spallation of the Ni_2Al_3 coating lies in the difference in thermal expansion coefficients between the steel, Ni, Ni-Al intermetallics forming at the interface and the Ni_2Al_3 . The coefficients of thermal expansion (CTE) for the steels, Ni, NiAl and Ni_2Al_3 are depicted in Figure 19. For the

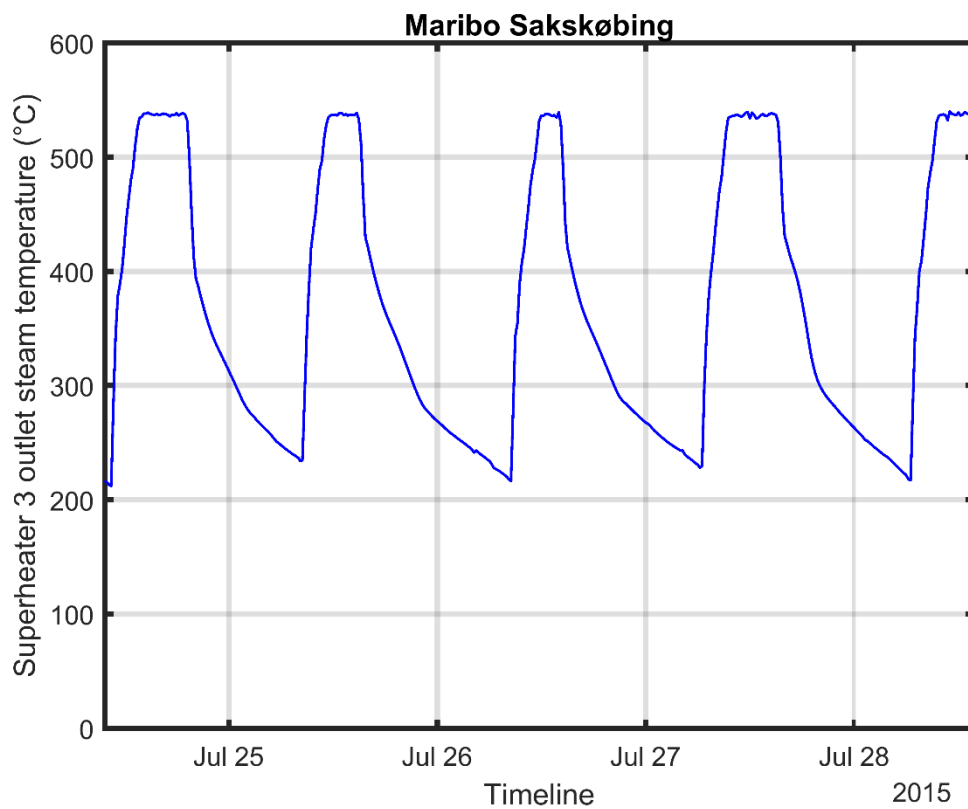
Figure 4. The outlet steam temperature data showing the daily cycle in MSK.

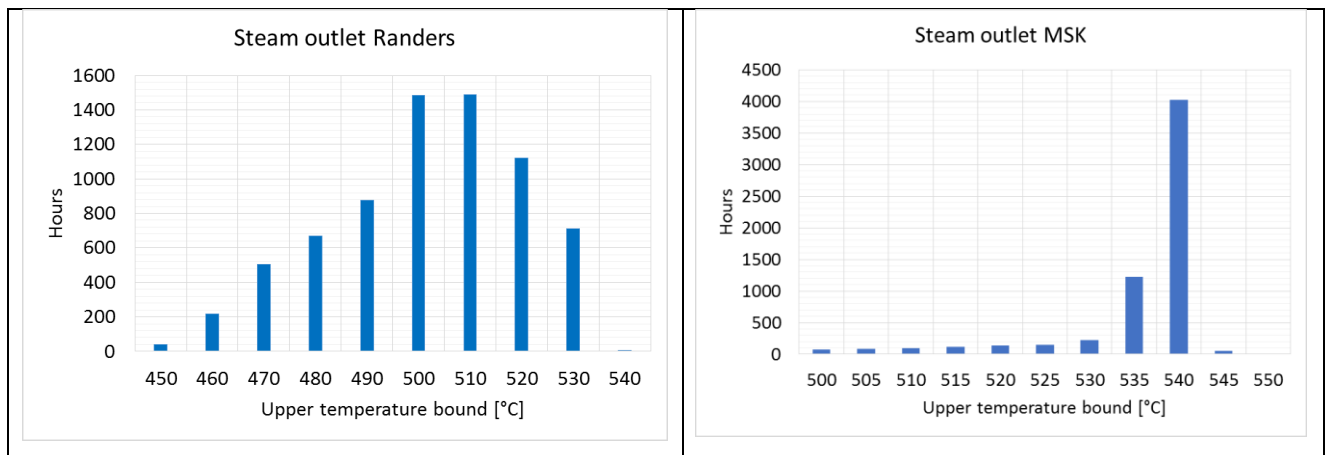
Figure 5. Temperature histograms for Randers and MSK.

The temperature data during the exposure period from Randers and MSK (Figures 2-5) show significant differences. The average test tube steam outlet temperature in Randers was 512 °C, while in MSK it was 544 °C. The significantly higher average steam temperature at MSK than at Randers would obviously increase the degree of fireside corrosion. Randers also has a broader temperature range with a significant amount of hours below 500°C where there would be minimal corrosion for an austenitic steel. As has been previously observed for these types of steels,⁵ corrosion increases significantly with increase in temperature and this is probably the main reason for the higher corrosion rates of the steel tubes observed for the MSK plant (Table 4). Another important factor is the thermal cycling of the plants. The plant in Randers has only had one shutdown during the entire exposure period and otherwise the operation temperature has been relative stable (Figure 2). This is in complete contrast to the MSK plant where frequent thermal cycling resulted in severe exposure conditions. At the MSK plant there has been three full shutdowns, but during autumn and late spring, there was thermal cycling every day between 200 and 540 °C (Figure 3 and Figure 4) resulting in 213 start/stop cycles (Table 2). This is with high certainty the reason behind the spallation of both Ni and Ni_2Al_3 coatings in the MSK boiler.

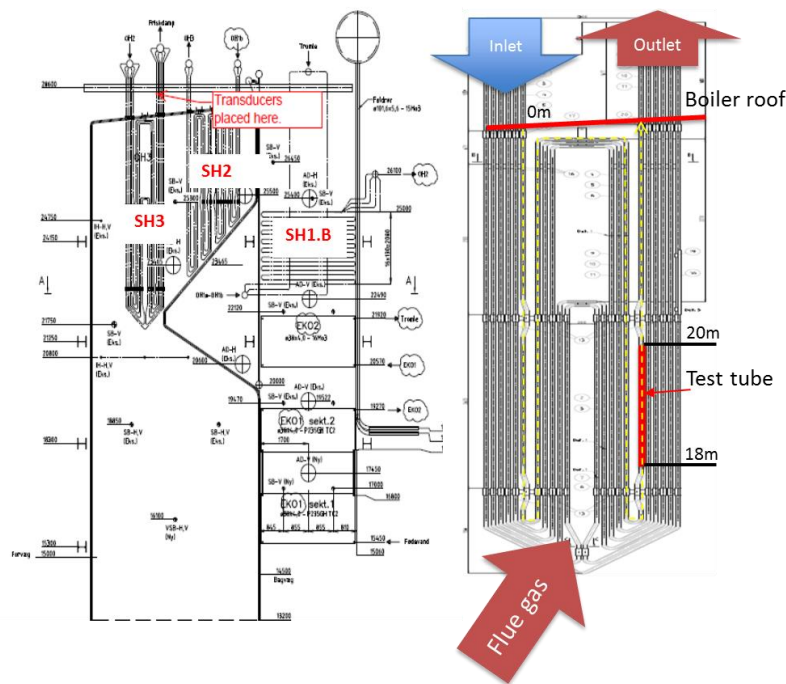
A cross-section of the Randers boiler, as well as superheater 3 (SH3) with the test tube is shown in Figure 6. SH3 has 14 parallel tube banks and the test tube was placed in bank no. 8, close to the centre of the boiler. The position of the test tube was chosen based on temperature analysis of the superheater with considerations to geometrical limitations. The temperature analysis was performed using a numerical tube model where the tube internal and external metal temperatures are calculated from inlet to outlet, under given boundary conditions (inlet/outlet steam temperature, steamside oxide thickness, material properties, heat flux profile, pressure, etc.).²⁶ The oxide thickness is calculated in the model as a simulation from new to actual time of operation. The oxide growth kinetics is based on tube investigations from other plants with the same materials. A bimodal flux profile was assumed for the Randers analysis, due to the double pass of the SH tubes. The heat flux is assumed to be the highest near the bottom (closest to the grate) and the lowest at the boiler roof. The resulting temperature profile from inlet to outlet at a steam outlet temperature of 512°C is shown in Figure 7. The metal temperature, which controls the corrosion process, is the highest in the high flux areas, and peaks around 19 m from the inlet (with the chosen flux profile). The test tube was placed 18-20 m from the inlet as indicated in Figure 6, i.e. at the peak metal temperature. The position is easy to access and the tube outlet temperature is measured with a thermocouple.

Figure 6. Cross-section of Randers boiler and position of the test tube on superheater 3.

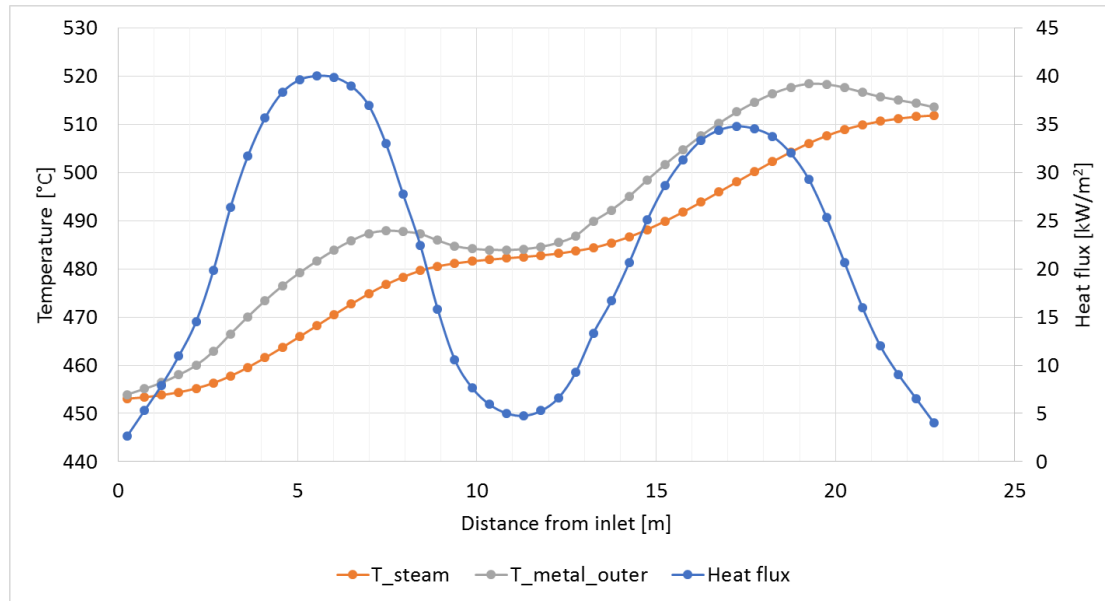
Figure 7. Calculated steam and outer metal temperature of SH tube from inlet to outlet in Randers. The test tube was placed from 18-20 m from the inlet.

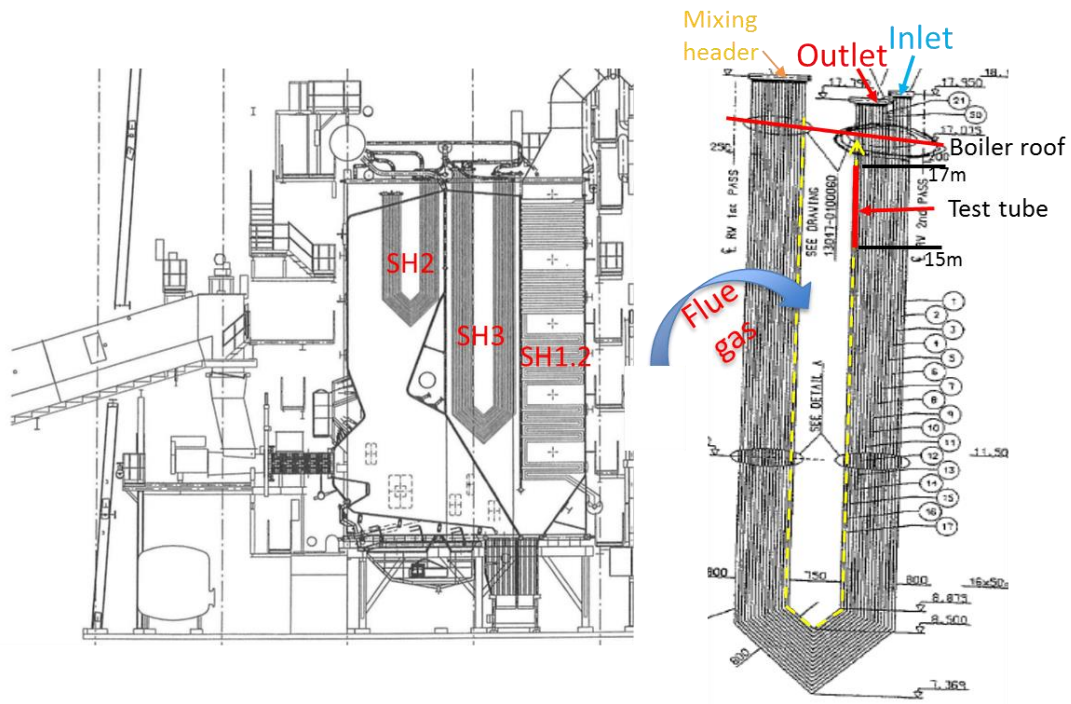
In Figure 8, a cross section of the MSK boiler and superheater 3 (SH3) is shown. At MSK, SH3 is placed in the second pass of the boiler as indicated. SH3 has 8 parallel tube banks and the test tube is placed in bank no. 4, close to the centre of the boiler. The position of the test tube was chosen in the same way as in Randers. For MSK a parabolic heat flux was chosen. This profile was chosen based on the assumption that the heat flux (flue gas flow and temperature) is slightly higher near the nose of the boiler compared to the boiler roof. The results of the temperature analysis are shown in Figure 9. Due to the lower overall heat input, and lower steam mass flow, the average heat flux is lower at MSK than in Randers. With the chosen flux profile, the outer metal temperature is almost parallel to the steam temperature and reaches the highest value at the superheater outlet. The test tube was placed close to the outlet, approximately 0.4 m under the boiler roof. This area is also reported from the plant operator to have high corrosion rates. Analysis of temperature measurements from tubes adjacent the test tube indicates that the steam temperature is approximately 8°C above the average steam temperature. Therefore, 8°C has been added to the average steam temperature in this analysis (see Table 2).

Figure 8. Cross-section of MSK boiler and position of the test tube on superheater 3.

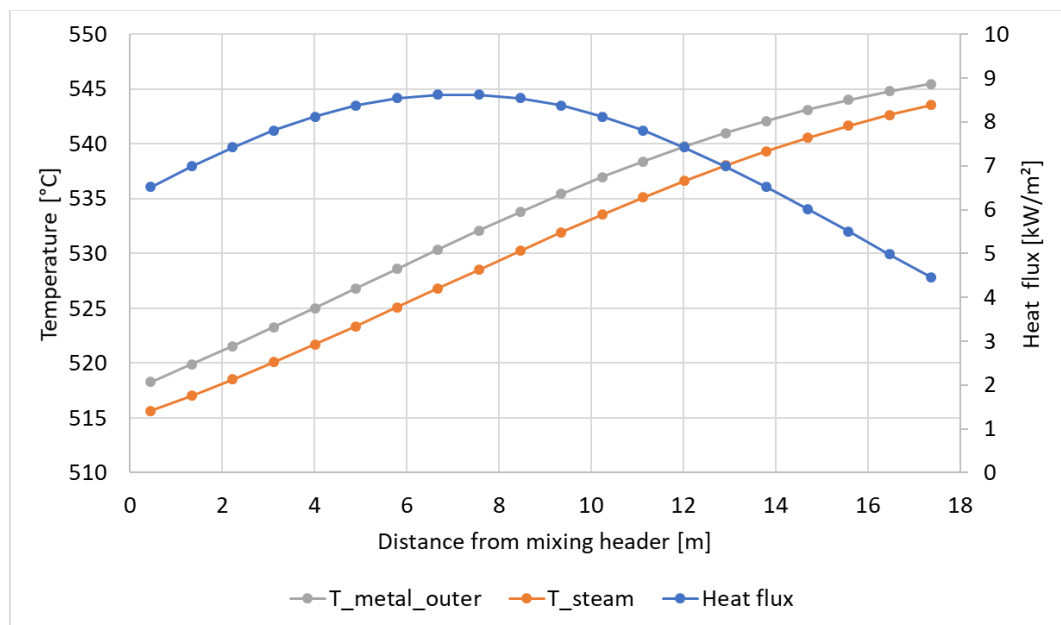
Figure 9. Calculated steam and outer metal temperature of SH tube from mixing header to outlet in MSK. The test tube was placed from 15-17 m close to the outlet.

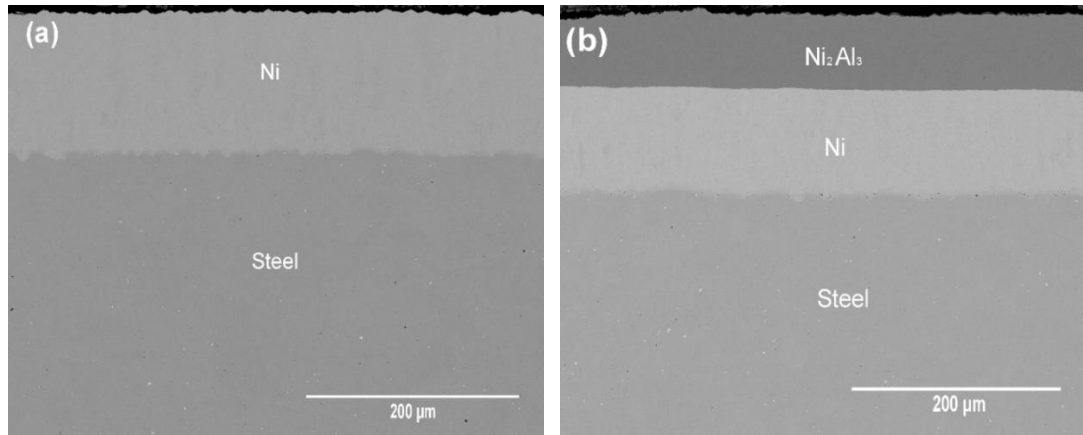
A cross sectional view of the Ni and Ni₂Al₃ coated samples are shown in Figure 10. The Ni coating consisted of a single Ni layer with a thickness of 135(\pm 5) μm . The Ni₂Al₃ coating, with a double layer structure, was adherent to the steel. The double layer coating consisted of an outer Ni₂Al₃ layer (thickness variation between 50 and 70 μm) and an inner Ni layer (100 μm).

Few small porosities could be observed locally at the Ni/steel interface, which indicates a good quality of the Ni deposition process. The presence of Ni₂Al₃ phase was confirmed by XRD (not shown). From the thermodynamic point of view, any stable phase at 650°C within the Al-Ni binary phase diagram can form during the coating preparation process. In practice, however, kinetics play a large role and only Ni₂Al₃ was observed directly after the low temperature aluminizing process. The reason is that the interdiffusion coefficient for Ni₂Al₃ is at least two orders of magnitude higher than for the other nickel aluminides.²⁷

Figure 10. BSE micrograph of the as coated samples for (a) Ni coated and (b) Ni_2Al_3 coated.

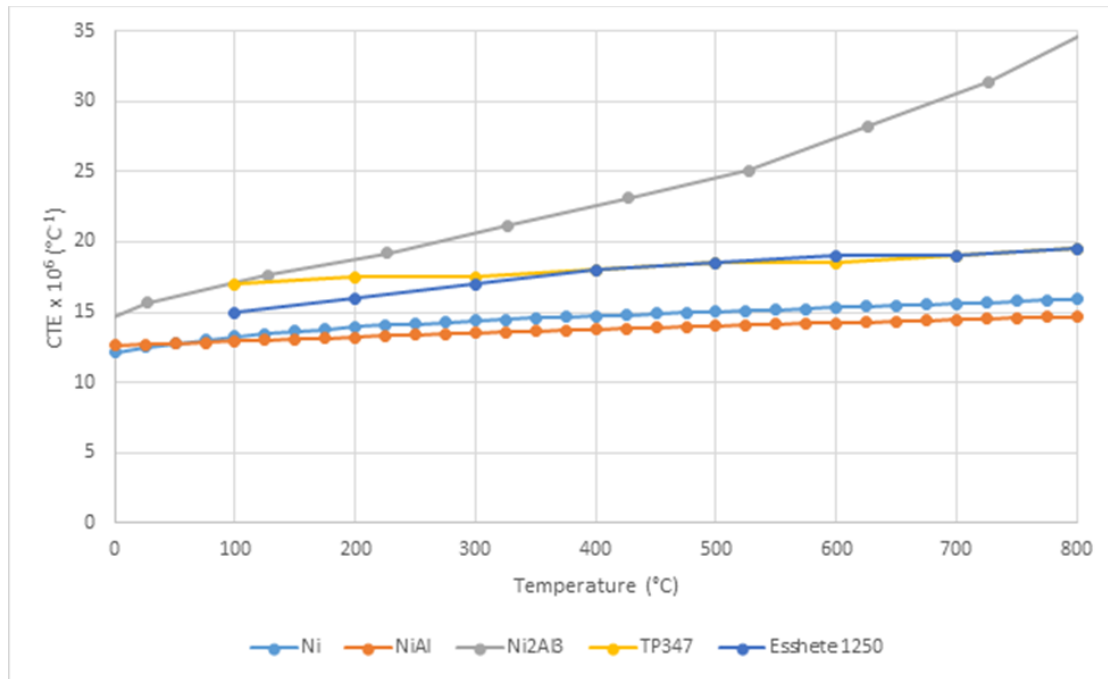
power plant exposure temperature interval between 300°C and 600°C as shown in Figures 3 and 4, the CTE for Ni_2Al_3 differs significantly from the CTE for Ni, NiAl and steels. A full stress analysis is outside of the scope of the present paper, however, as the CTE for Ni_2Al_3 and Ni are quite different, thermal stresses could be expected which would lead to the spallation of the Ni_2Al_3 coating in MSK. The spallation of Ni from the steel was probably related to the corrosion attack of the underlying steel which led to a weak adhesion between Ni and steel.

Figure 19. The variation of CTE with temperature of pure Ni, NiAl, Ni_2Al_3 , TP347H and Esshete 1250.^{36,37}
